123 Anywhere
Royse City, TX 75189

PROPERTY INSPECTION REPORT FORM

Sample Report Name of Client	06/21/2023 Date of Inspection
123 Anywhere, Royse City, TX 75189 Address of Inspected Property	
Devon Bailey Name of Inspector	8394 TREC License #
Name of Sponsor (if applicable)	TREC License #

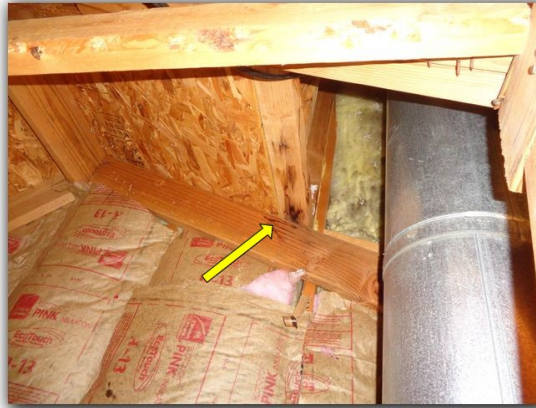
Moisture stain present in attic framing near the fireplace flue, suggest further evaluation of this area on the roof to ensure no present leakage exists.

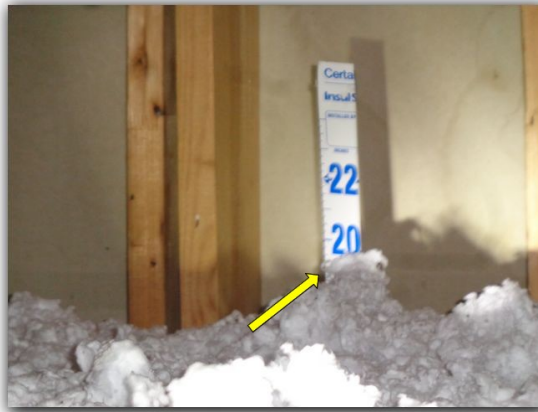
Approximate Average Depth of Insulation: 16-20 inches

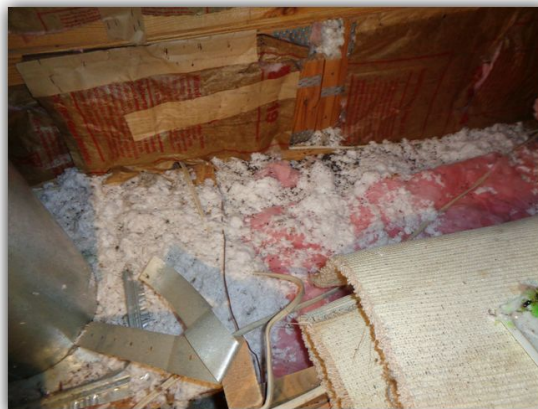
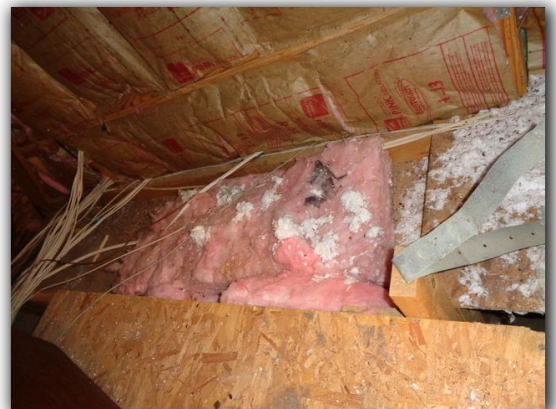
As stated in previous section, moisture stain at framing near fireplace flue.

Evidence of pest activity in the attic over garage, suggest further review by pest control specialist for abatement, as needed, and prevention.

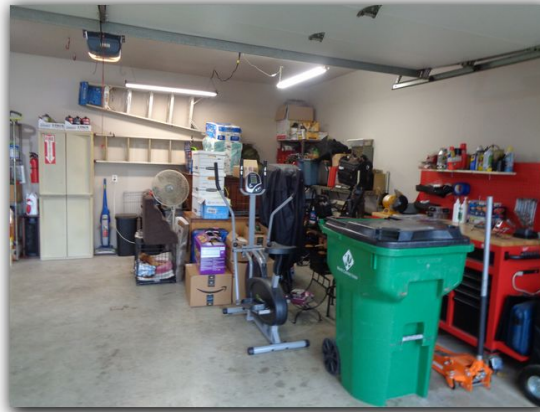
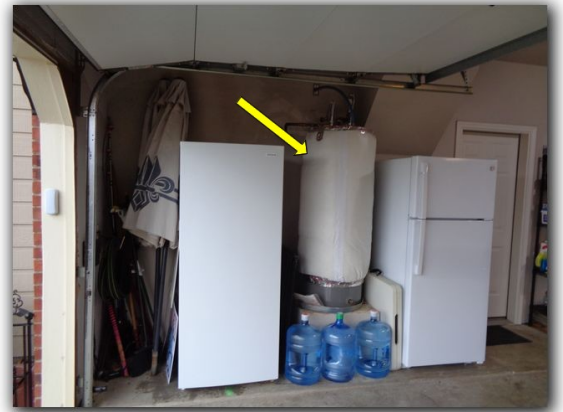
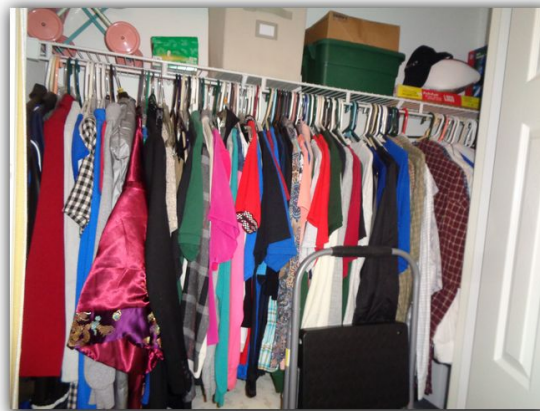
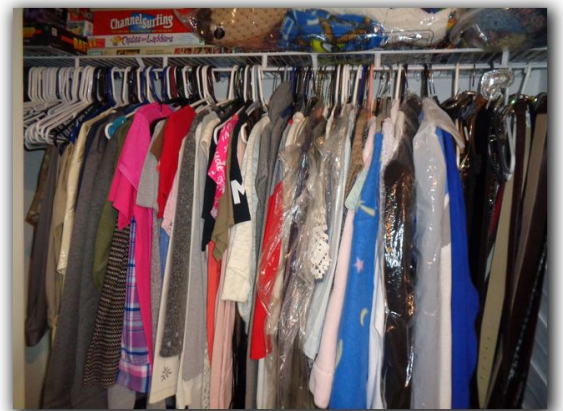
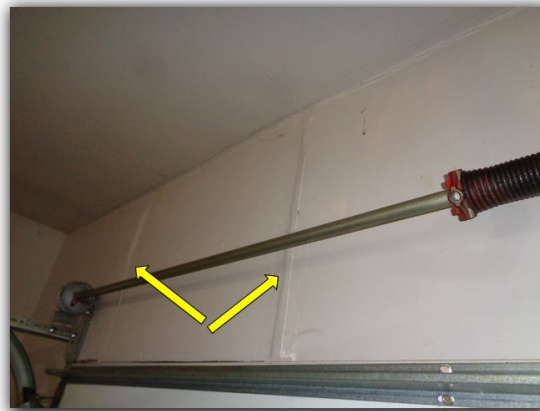
Hairline cracks and loose tape at garage sheet rock walls, typical in garages.

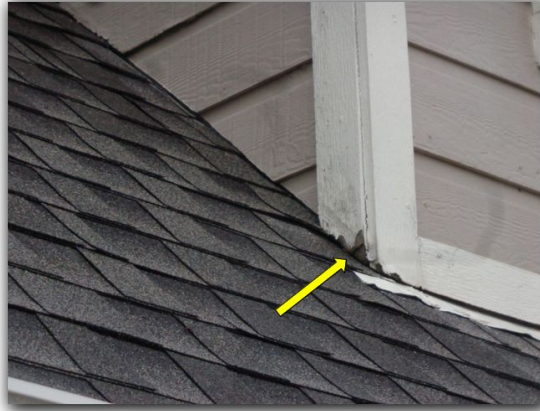
One or more areas of siding/trim needs paint/repair. Examples: bottom of trim at dormer

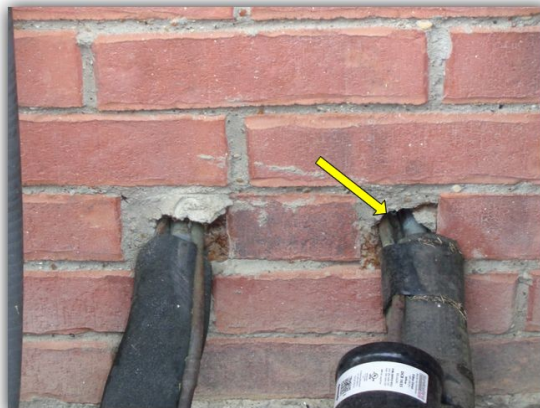
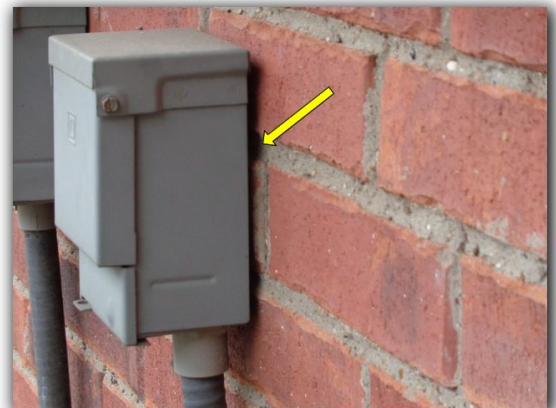
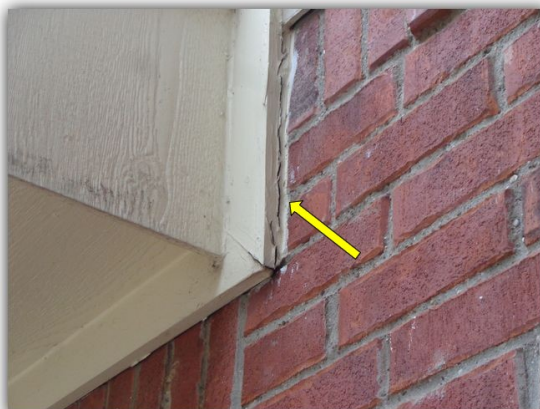
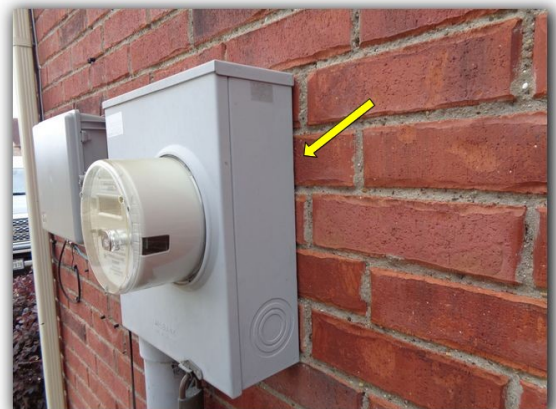
Open caulk joints at one or more locations-(doors, windows, and/or trim boards) at the exterior of the home. This is considered a routine maintenance issue and will need to be re-sealed periodically. Location examples: trim/siding junctions, exterior wall entry points(AC cutoff, electric meter base, AC refrigerant line)

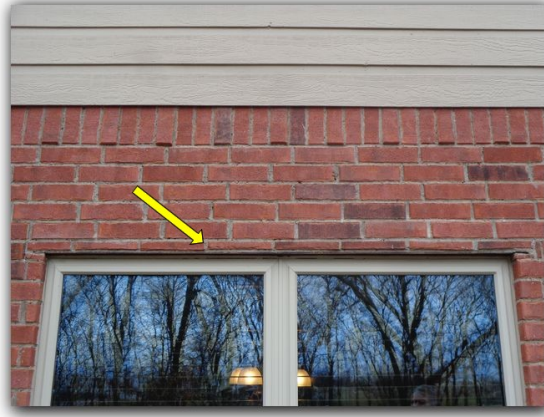
No weep holes present at bottom row of the brick veneer or above windows/doors where needed.

Weep holes allow water to drain from between the brick veneer and the wood wall structure. **Suggest drilling or cutting weep holes to allow for proper drainage. Examples: above windows with metal lintels**

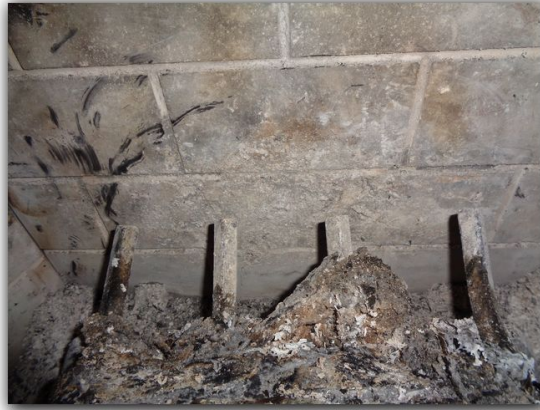
Rear refractory is damaged.

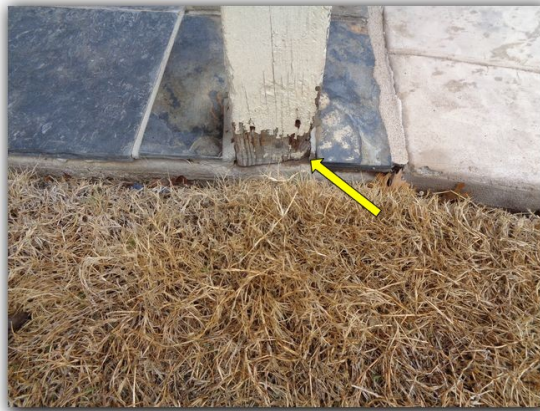
Some damage at bottom of rear porch support post.

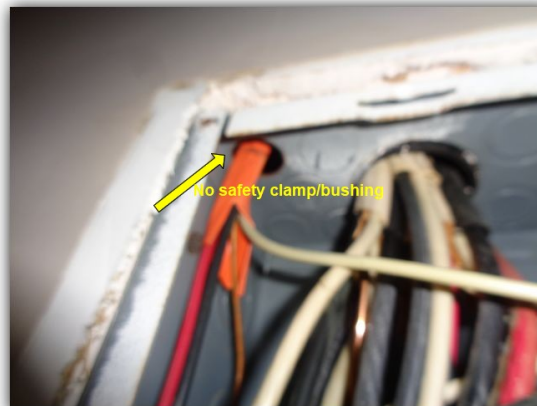
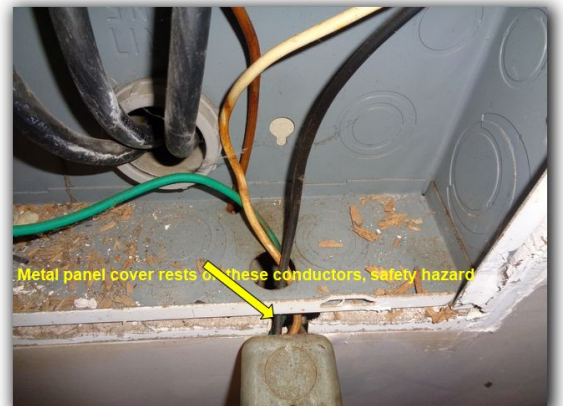
No safety clamps or protective bushings where the circuits entry the service panel. The conductors can become damaged on the sharp metal edges of the service panel. Suggest having clamps or protective bushings installed to protect the conductors.

The metal deadfront cover rests on electrical conductors that serve the receptacle that is directly below the panel, safety hazard.

Suggest further review and repair, as needed, by licensed electrician.

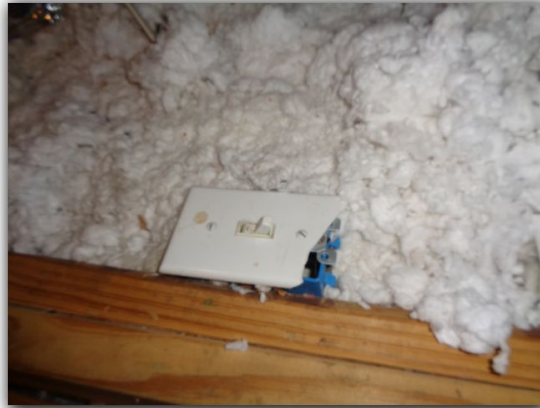
Damaged cover plate in attic near access.

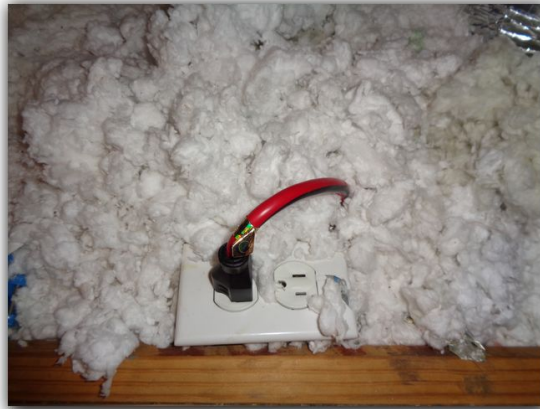
Note: extension cord plugged into receptacle near attic access, unsure what this is supplying power to, suggest ask seller.

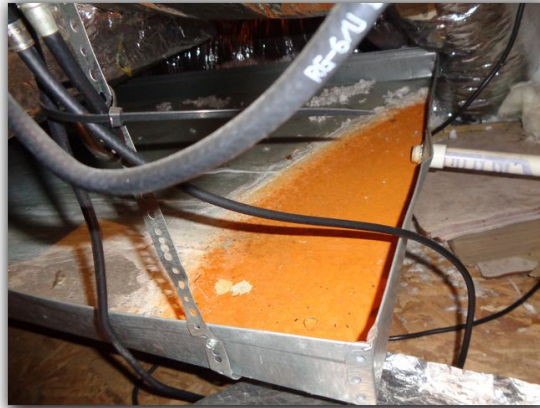
One or more of the a/c evaporator coil safety pans are rusted. Recommend replacement of rusted drain pans by an HVAC Co., also recommend having drain lines checked to make sure they are not stopped up. Examples: unit towards the front of the attic

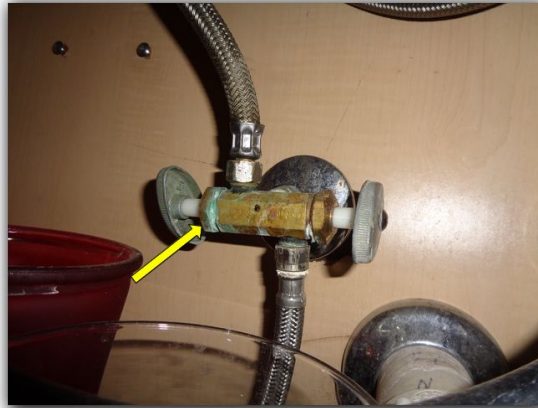
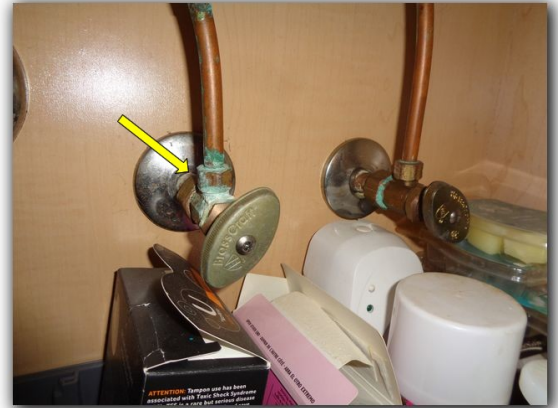
One or more areas of corrosion noted at the angle stop valves/supply line fittings under the sink(s). Possible future water leak. **Location example: kitchen, 1/2 bathroom**

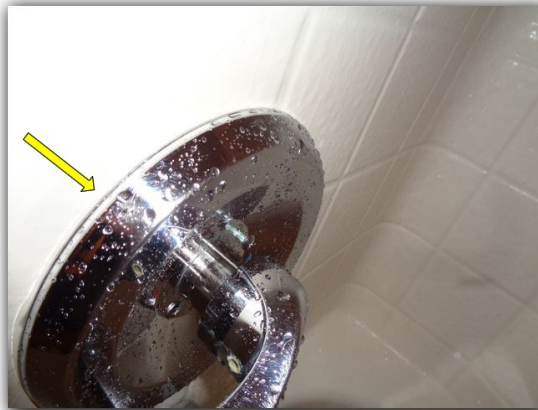
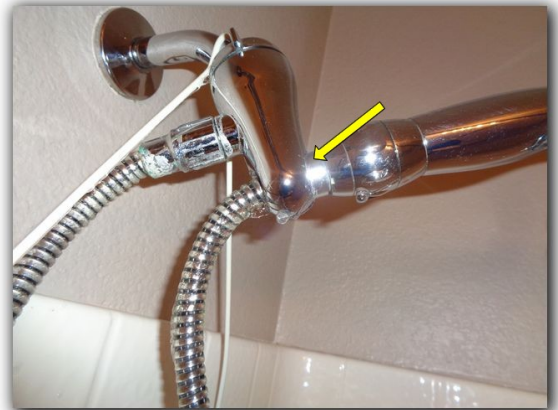
Upstairs bathroom tub/shower: leak at shower hose connections, tub spout/control needs caulk, water does not as hot as sink in same bathroom possible bad valve, 1 screw at the control knob trim is proud/not driven

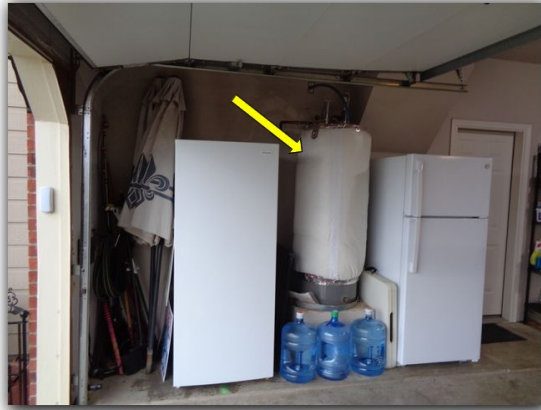
Note: water heater wrapped with insulated blanket, obstructed view.

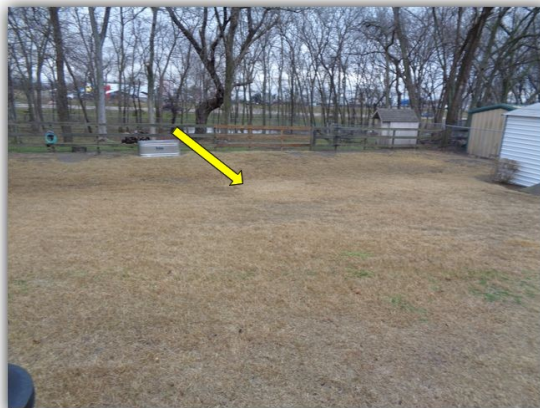
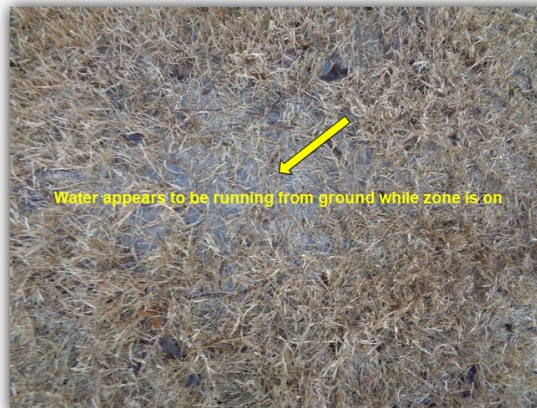
Appears to be a leak in zone 5 of rear yard between mid yard and building.

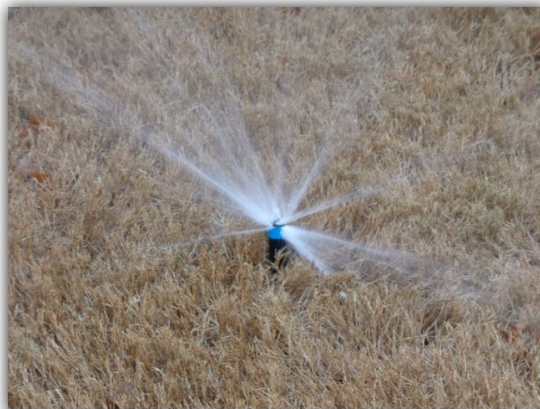
Damaged nozzle with erratic spray right side front of home, zone 7.

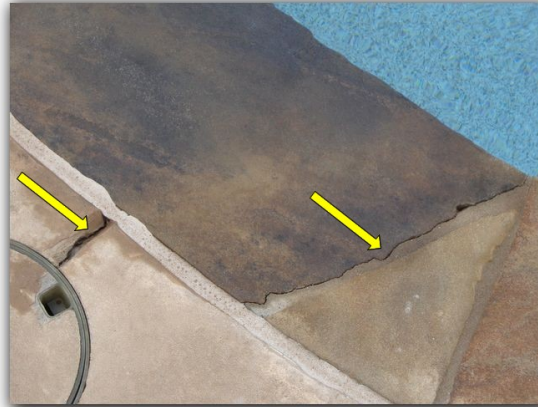
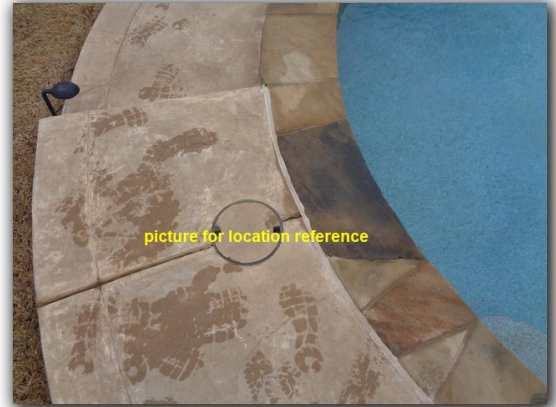
Crack present in deck near skimmer basket that is close to steps.
